University  
of Glasgow

## Fire (Scotland) Act 2005 Fire Risk Assessment Review

Kelvin Building

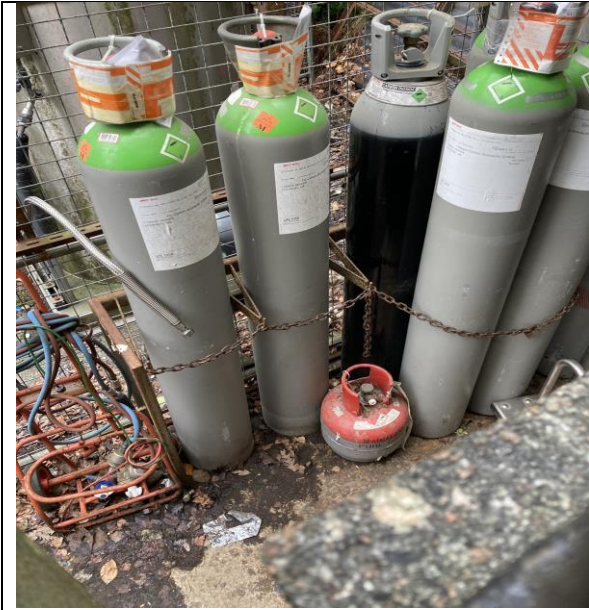
Cylinder compound under external escape stair.

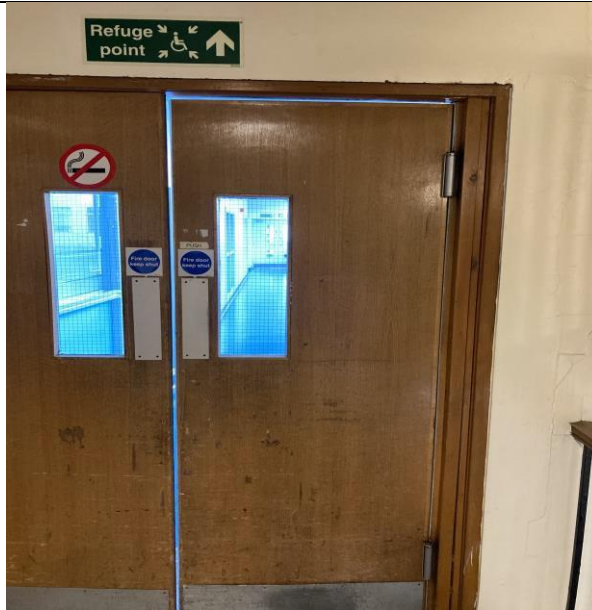
Evidence of fire door requiring maintenance and non-compliant hinges.

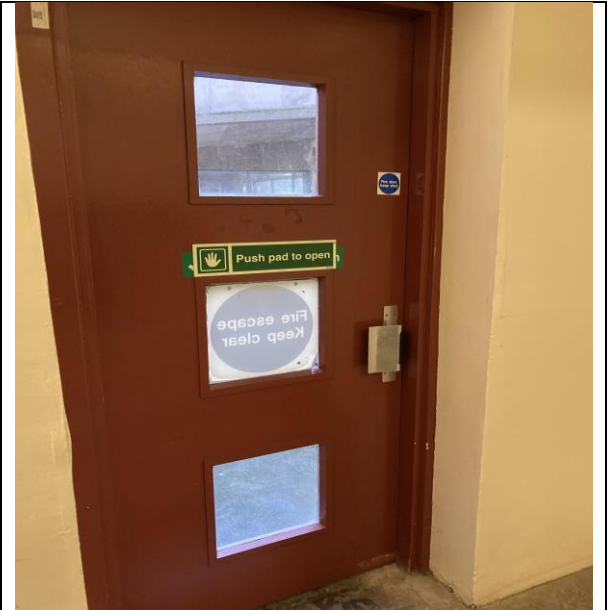
Nonstandard fastenings should be removed and replaced as required.

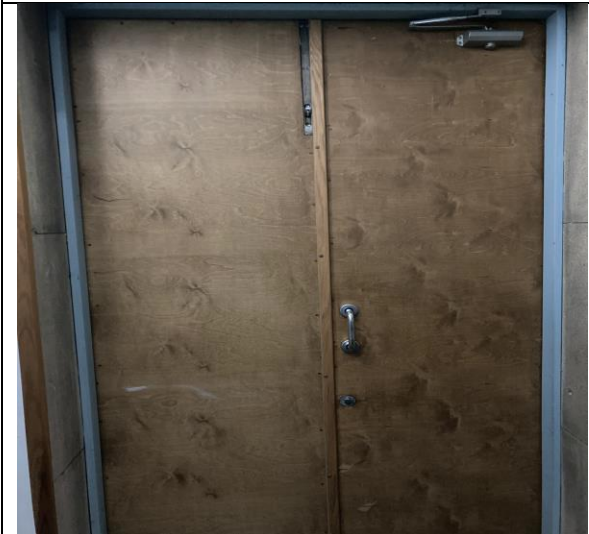
Final exit doors from lecture room require push bars and thumb turn lock removed.

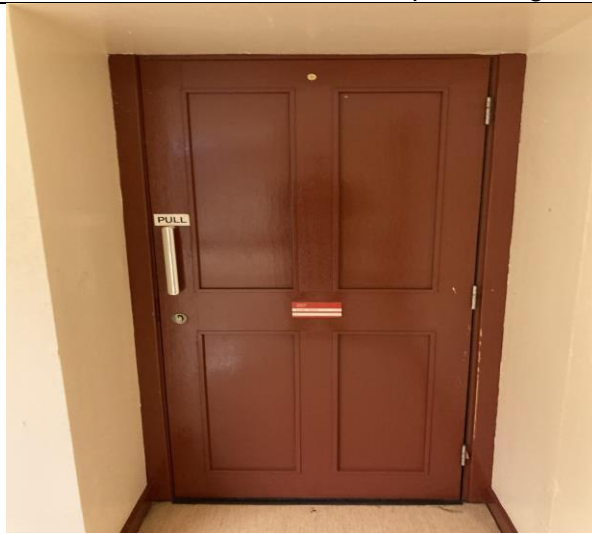
Evidence of no "fire exit keep clear" signage from lecture room.

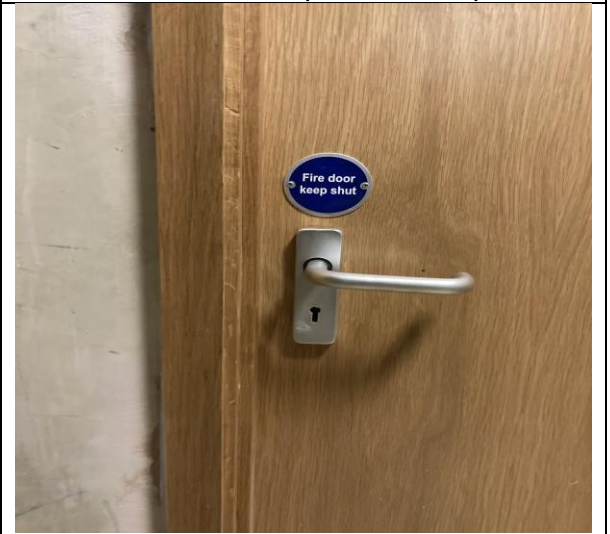
Evidence of wrong mandatory signage on cupboard on escape route.

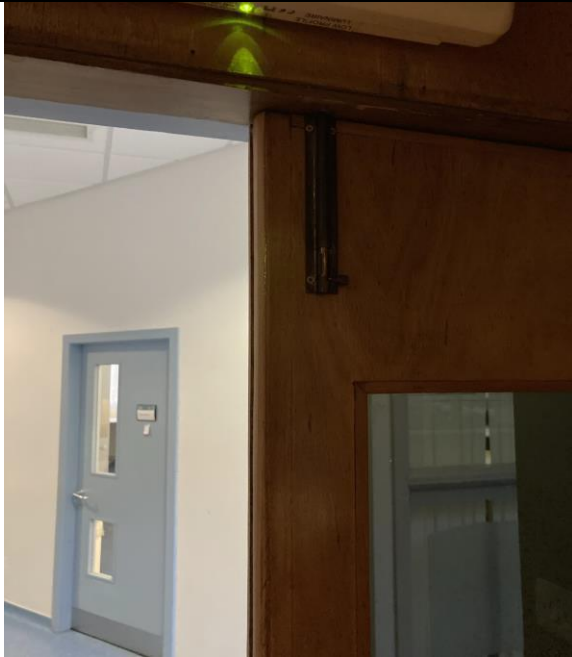
Bolts on lecture room door.

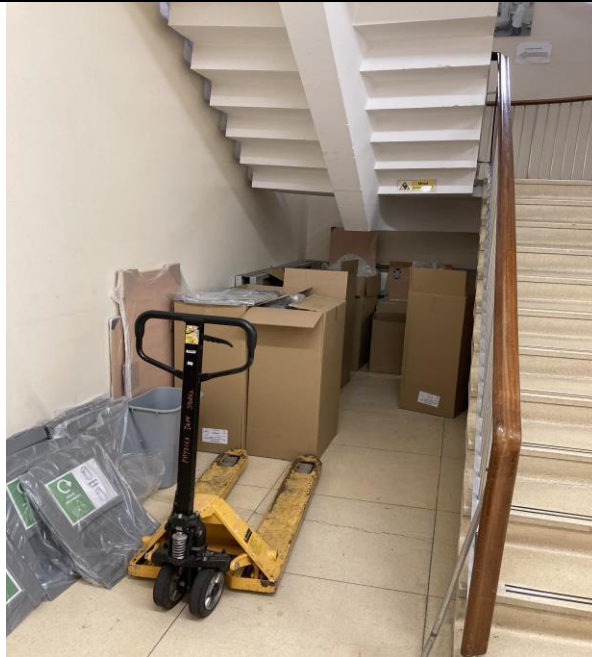
Evidence of poor housekeeping.

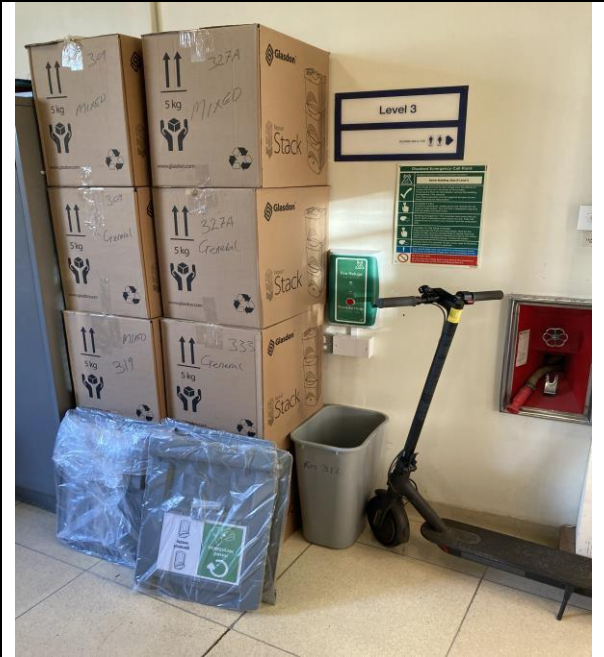
Evidence of poor housekeeping and blocking TWS.

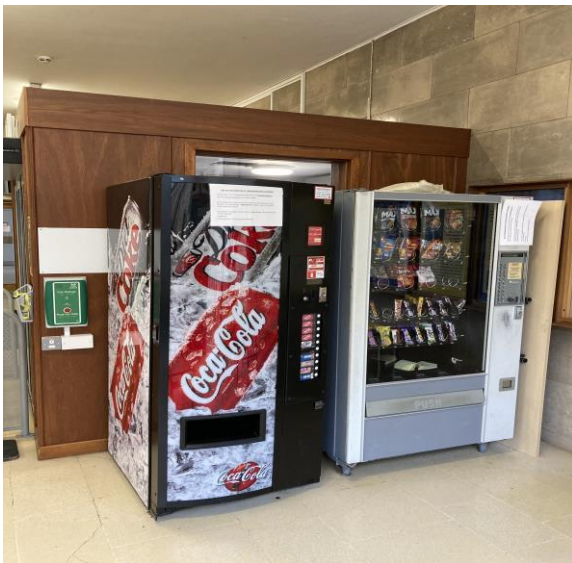
Unsuitable items in an escape route.

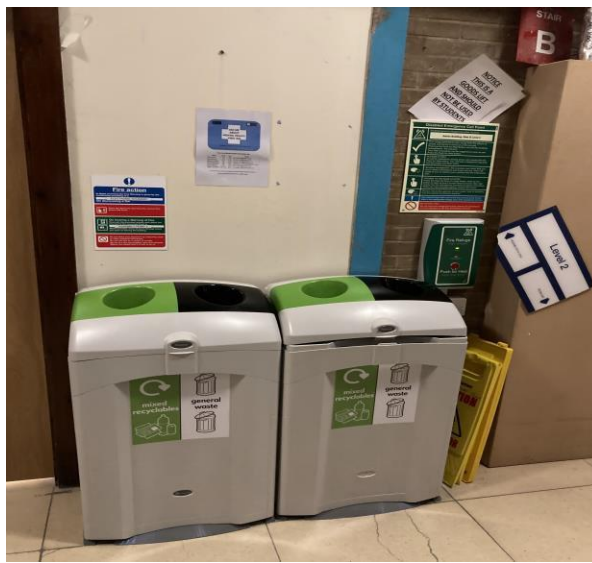
Unsuitable items in an escape route and blocking TWS.

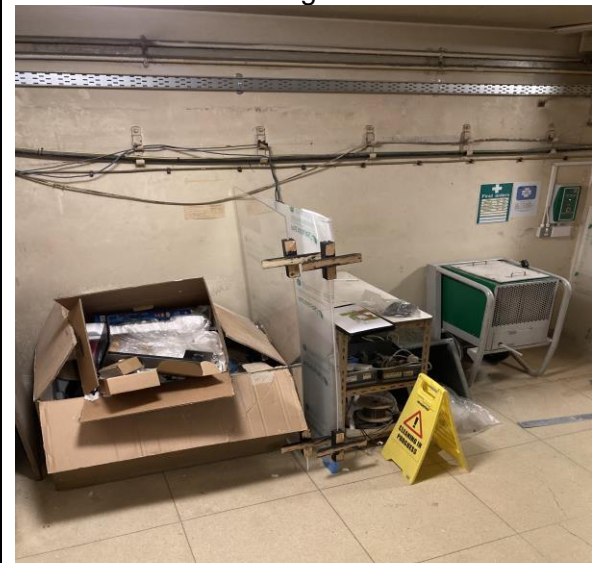
Unsuitable items in an escape stair and blocking TWS.

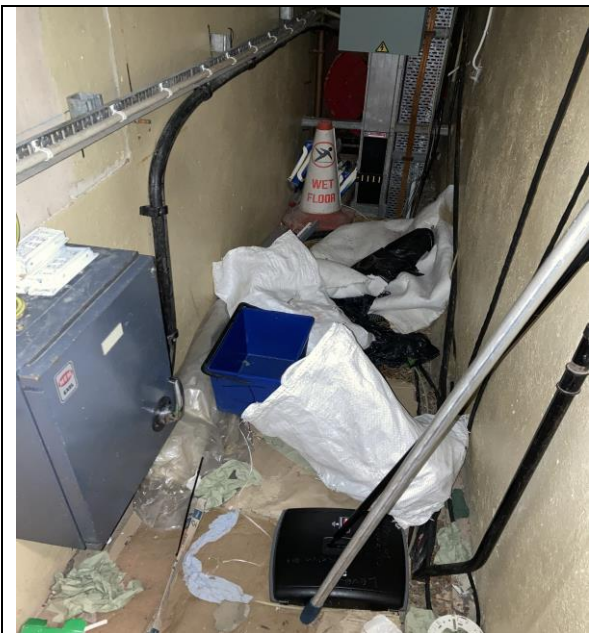
Combustibles stored next to electrical installation.

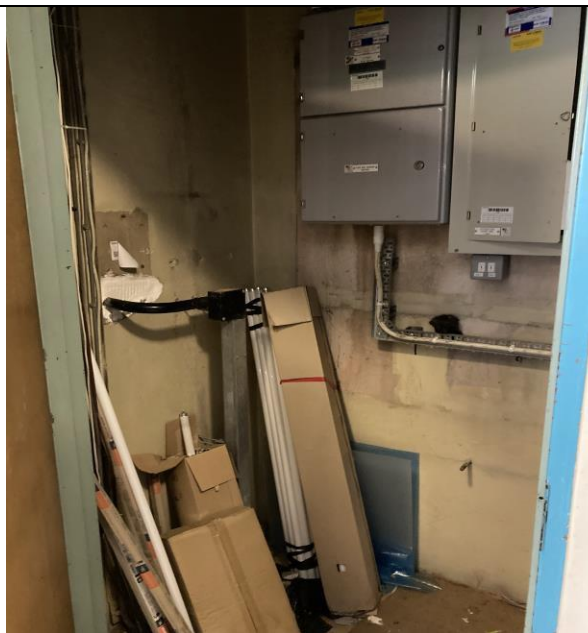
Combustibles stored next to electrical installation.

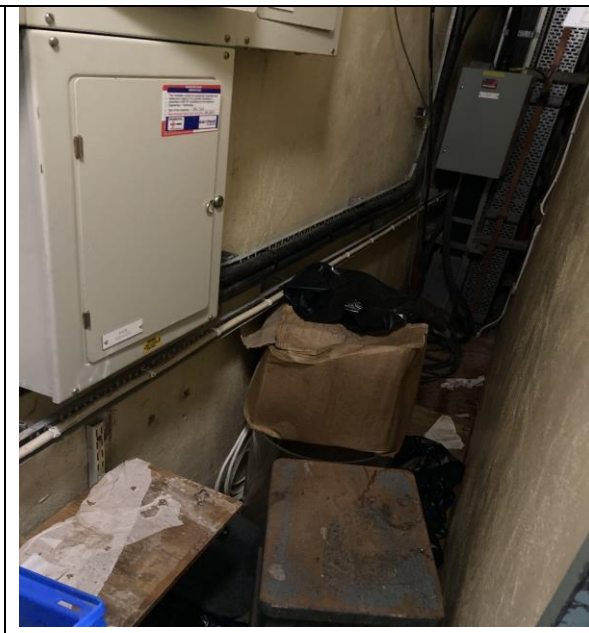
Combustibles stored next to electrical installation.

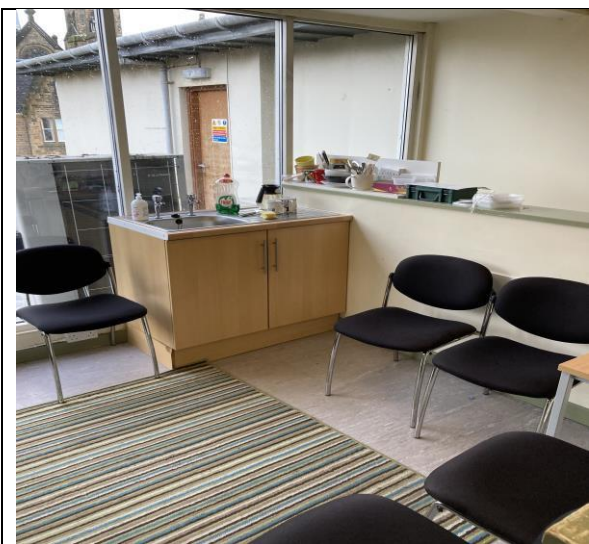
Escape routes should not be used as kitchens/tea prep areas.

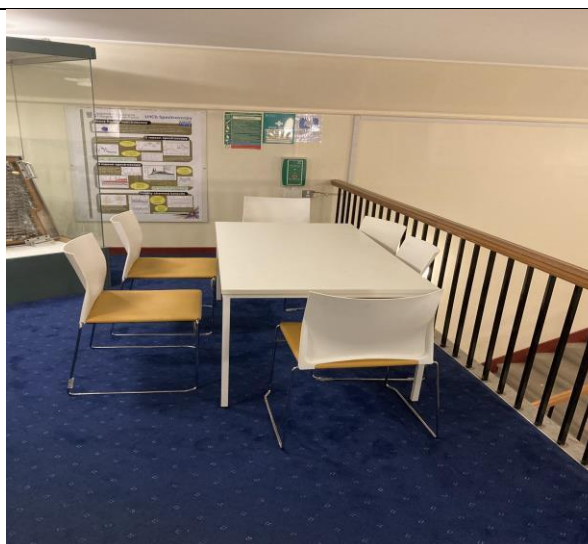
Escape routes should not be used as a place of work.

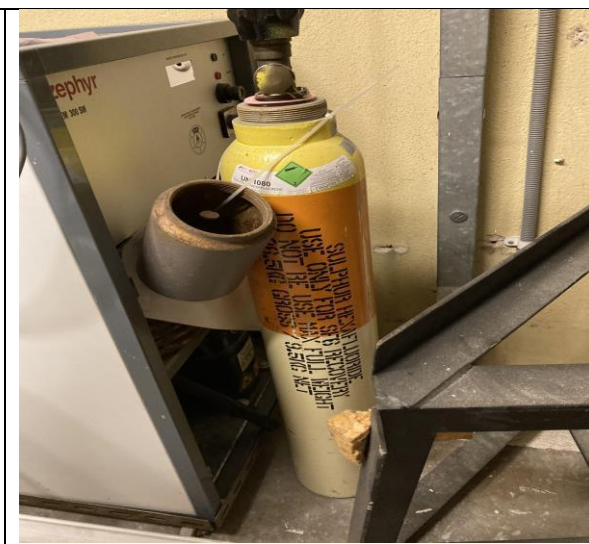
Compressed gas cylinder left in cupboard.

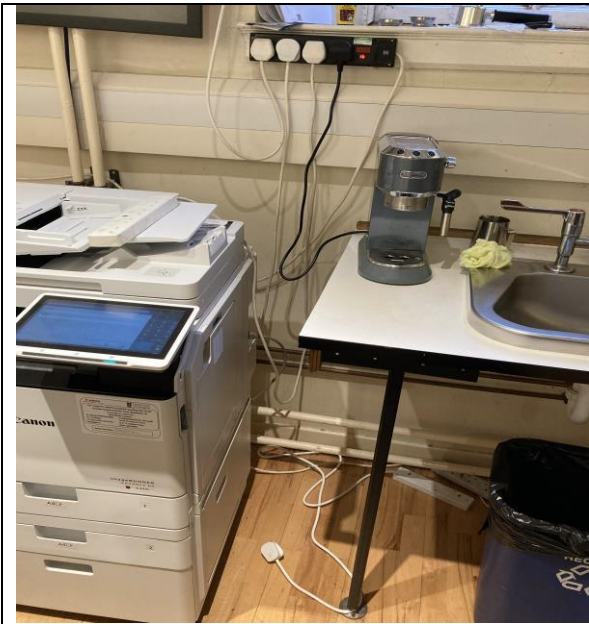
There was evidence of daisy chaining (two 4-gang adapters joined together) in room 157B on level 1. This has the potential to overload the 13A socket.	HMU		X	
		There is some evidence of portable appliance testing (PAT) being carried out in March 2020 although not all appliances have been tested. If this is carried out inhouse then the PAT machine requires to be calibrated.	HMU		X

Evidence of daisy chaining.

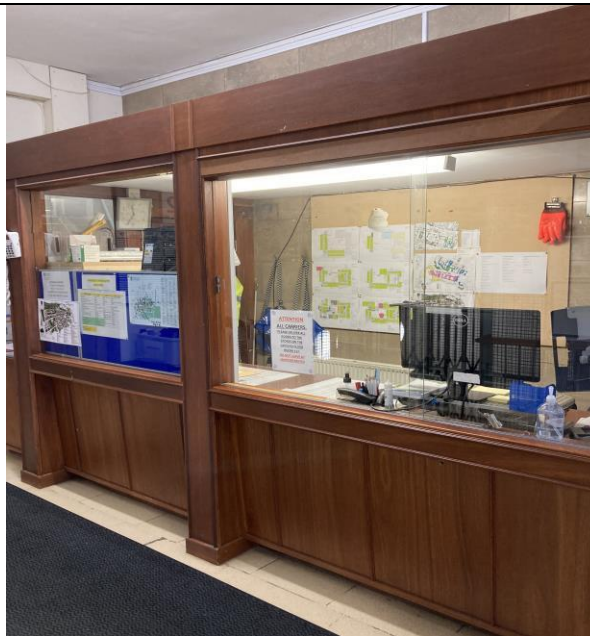
This room requires to be separated from the escape stair by fire resistant material or removed.

11.	The facilities room on level 2 forms part of escape stair A and should be adequately separated off from the entrance hall with a minimum 60 minute fire resistant partition and fire door. Alternatively, the partition forming the room should be removed or all combustible material removed.	ED		
		Although some fire stopping has been carried not all work has been completed. Any further surveys should include the ventilation system, service risers and some walls enclosing escape routes.	ED		
		Due to listed building status consideration should be given to treating certain wall materials on escape routes with intumescent coating.	ED		
		When new HV/LV electrical equipment is installed, these spaces require to be enclosed	ED

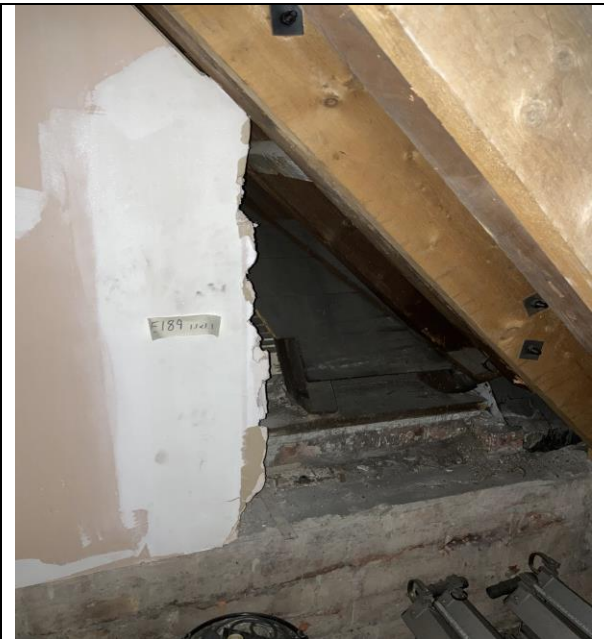
Area (void on L4) for potential fire spread.

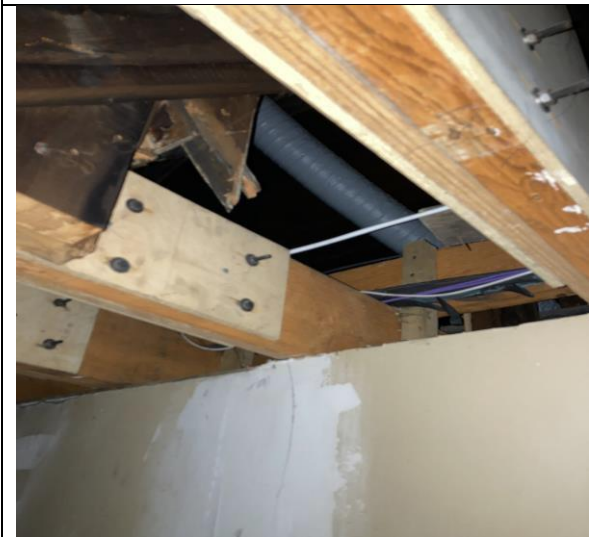
Area (void on L4) for potential fire spread.

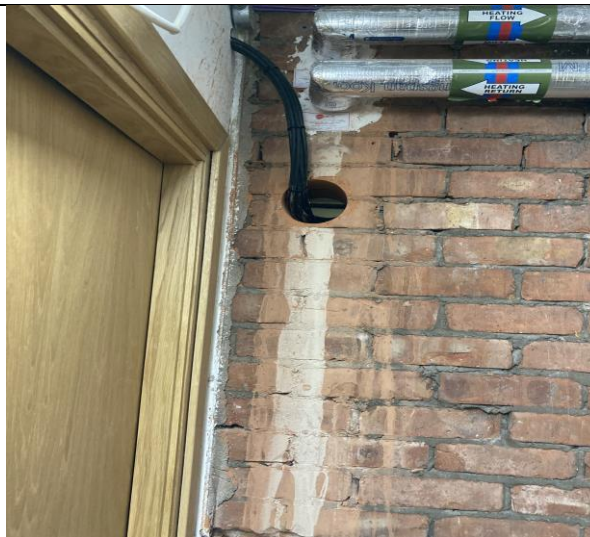
Area (L3 stair B) for potential fire spread.

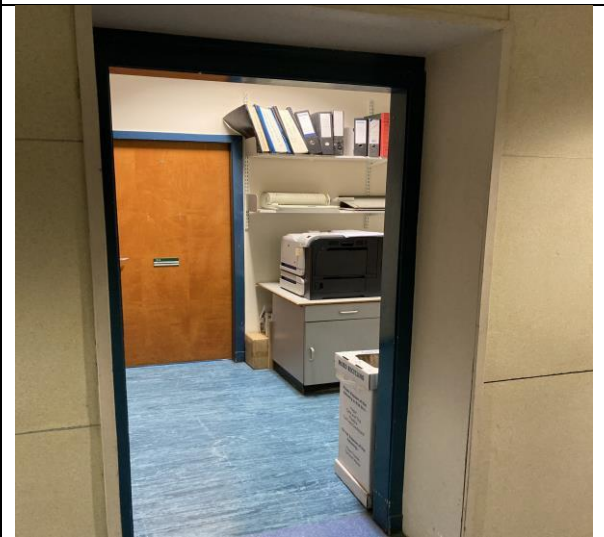
Door has been removed from lobby.

Where doors to lobbies have been removed, these lobbies cannot be used for office equipment or storage. There is also no automatic fire detection within the lobbies.	<b>ED</b>		
	Compressed gas cylinders should not be stored in corridors or left randomly in cupboards. The old Butane cylinder left in the outside compound should be disposed of.	<b>HMU</b>	There is a cylinder sited in the level 1 corridor outside the IGR lab. The Safety Committee and Fire Officer have instructed that the cylinder be removed. Estates are exploring a new location for it in conjunction with IGR.	
	Combustible material should not be stored against the building, particularly next to windows and vents.	<b>HMU</b>	All unwanted material must be correctly disposed of. There will be no storage of random & combustible materials in the courtyard, corridors, under the stairs or against the building. Facilities and stores staff are each maintaining a careful watch on the courtyard; swift action is taken to remove any such material.

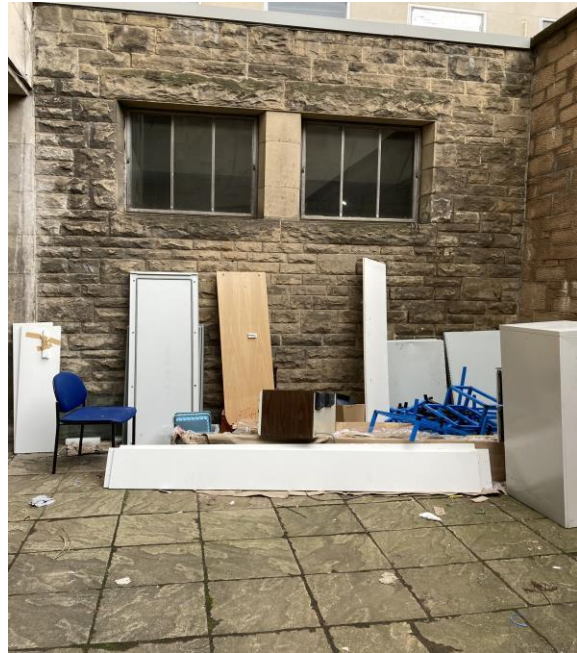
Combustible material stored next to building.

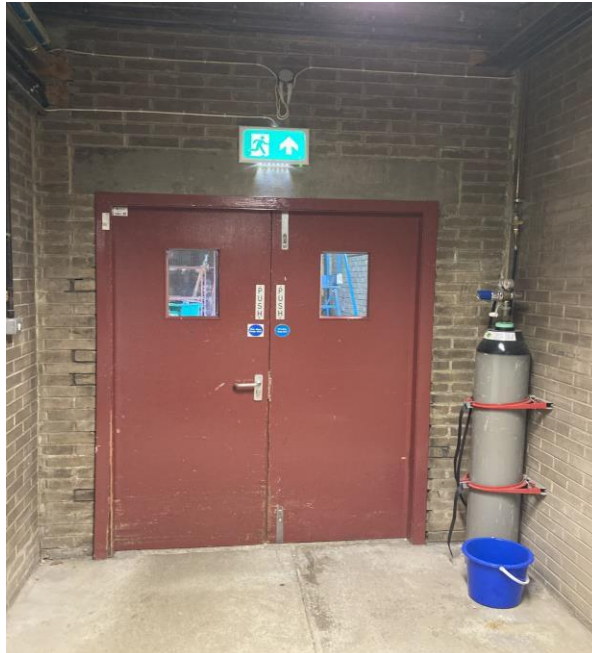
Compressed gas cylinder located in a corridor.

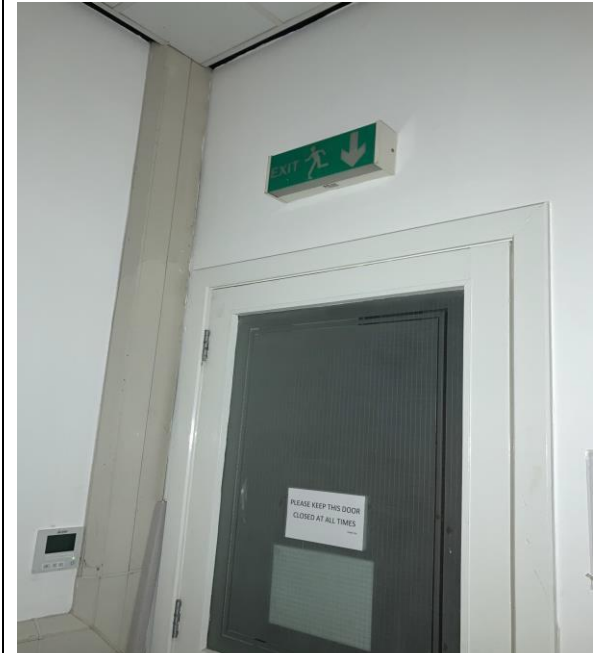
Example of older type emergency lighting.

8.	A full survey is required to make sure EL and directional signage is adequate, this should include the external escape routes including the one on the roof.	ED		
	Having numbers marked on FAN has the potential to be confusing. The actual location would be more helpful.	HMU/ ED	Maintaining the signage is a matter for Estates.
